**Texas General Land Office
Community Development and Revitalization
Damage Assessment Guidelines**

Damage Assessment Guidelines (Single Family Housing)

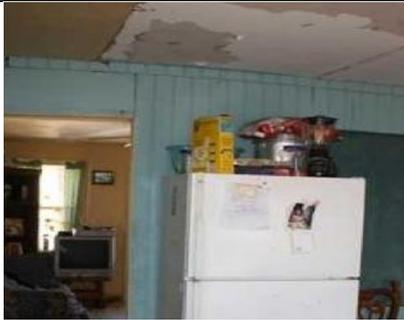
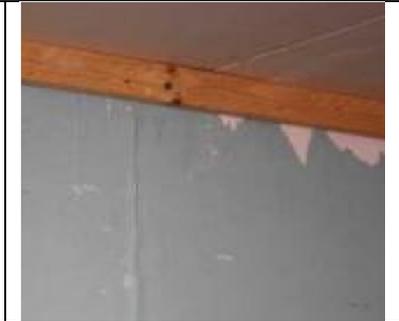
Project I.D.	Inspection Date	Evidence of Storm Damage	Photographic Evidence of Storm Damage	
XXXXXXXXXX	XX-XX-XXXX	<p>Applicant: Home received 2- 3 feet of water from the storm surge causing damage to the walls, floors, doors, cabinetry, appliances, electrical, and plumbing system. In addition, strong winds damaged the roof covering which allowed rain water to enter home and damage some of the ceilings, walls, and floors.</p> <p>DCT Inspector: Exterior: roofing, siding and piers; Interior: Floors, walls, ceilings and electrical.</p> <p>ECR Inspector: Siding, roof, fascia/soffit, foundation and piers are damaged. Drywall is damaged or has poor workmanship. Sub floor is damaged in all rooms and flooring is damaged in most of the rooms.</p>

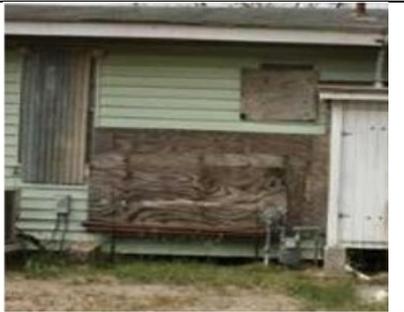
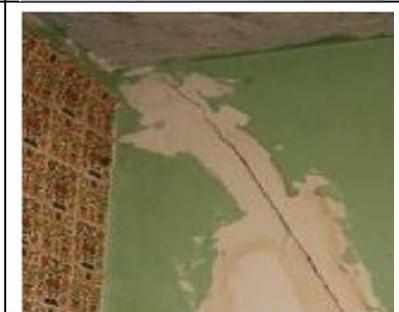
XXXXXXXXXX	XX-XX-XXXX	<p>Applicant: The roof covering was damaged by wind and has not been replaced. Water entered through the roof damaging ceilings, walls and flooring. The area beneath the home received 2-3 feet of water from the storm surge which caused damage to some of the electrical and plumbing components.</p> <p>DCT Inspector: Exterior wind and rain damage. Interior water damage (flooring, walls and windows).</p> <p>ECR Inspector: Hurricane damage- roofing; water damage to interior ceilings, walls and floors.</p>

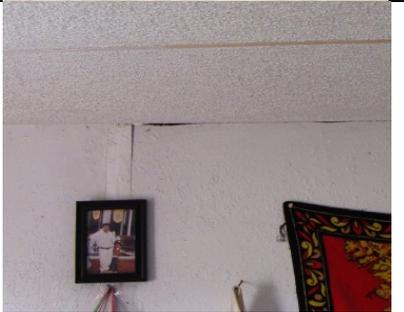
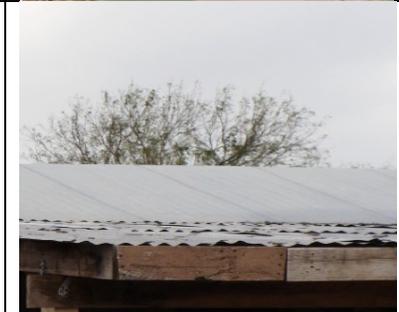
XXXXXXXXXX	XX-XX-XXXX	<p>Applicant: N/A; this is a mobile home 11.01A.</p> <p>DCT Inspector: App States H2O entered through vent making floors warp and water stained ceiling.</p> <p>ECR Inspector: Damage from the event was observed on the site. Photographic evidence documents broken and cracked windows, interior ceiling damage, and damaged roofing.</p>

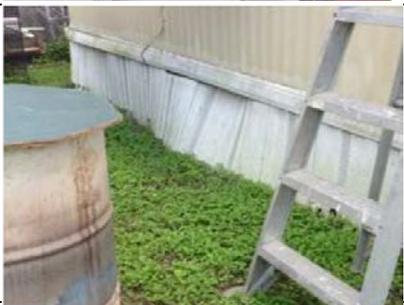
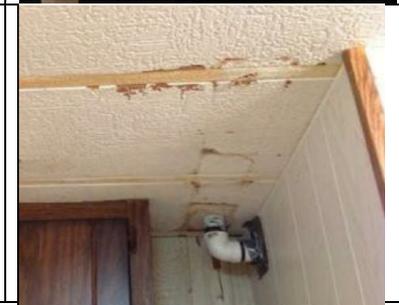
XXXXXXXXXX	XX/XX/XXXX	<p>Applicant: N/A, this is a mobile home 11.01A.</p> <p>DCT Inspector: Ext: roof, leveling, bottom floor board and insulation; Interior: ceiling, walls and floors.</p> <p>ECR Inspector: Due to the extent of the storm damage from the event coupled with HQS and code violations, the cost of repair for this structure is over the program rehabilitation cap. Therefore, a reconstruction is recommended. Photographic evidence of interior ceiling damage from roof leak.</p>

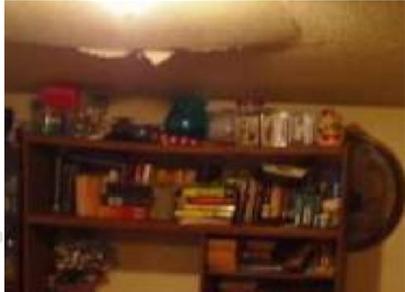
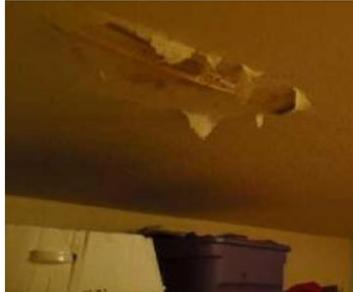
Activity Number	Inspection Date	Evidence of Storm Damage	Photographic Evidence of Storm Damage	
XXXXXXXXXX	XX-XX-XXXX	<p>Applicant: N/A, this is a mobile home 11.01A.</p> <p>DCT Inspector: Exterior: roof, leveling, bottom floor board and insulation; Interior: ceiling, walls and floors.</p> <p>ECR Inspector: Due to the extent of the storm damage from the event coupled with HQS and code violations, the cost of repair for this structure is over the program rehabilitation cap. Therefore, a reconstruction is recommended. Photographic evidence of interior ceiling damage from roof leak.</p>

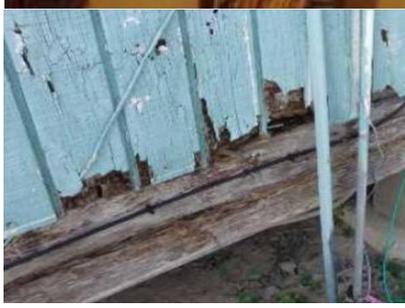
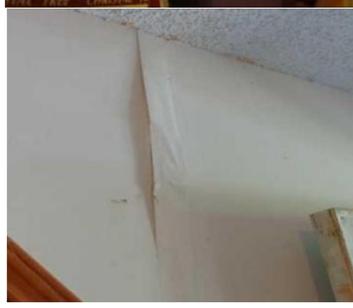
XXXXXXXXXX	XX-XX-XXXX	<p>Applicant: Strong winds damaged the roof covering which allowed rain water to enter and cause damage to some of the ceilings, walls, and floors.</p> <p>DCT Inspector: Interior: ceiling, walls and floors. Ext: roof, siding and piers.</p> <p>ECR Inspector: The roof is damaged and some siding is damaged or missing. Some ceilings and walls have water damage.</p>

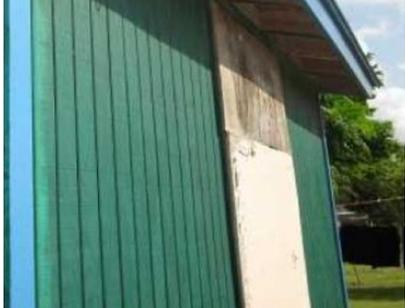
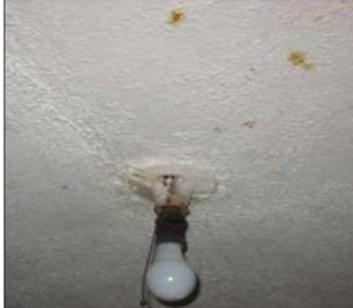
XXXXXXXXXX	XX-XX-XXXX	<p>Applicant: Strong winds damaged the roof covering which allowed rain water to enter home and cause damage to some of the ceilings, walls, and floors.</p> <p>DCT Inspector: Exterior: roof, siding and piers; Interior: ceiling, walls and floors.</p> <p>ECR Inspector: Roof is damaged. Some ceilings have water damage.</p>

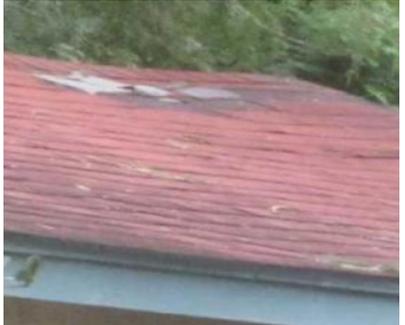
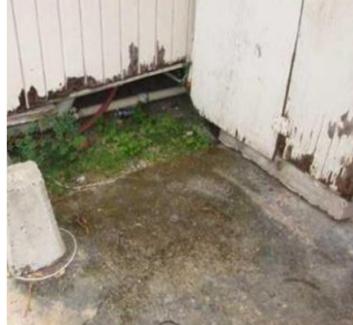
XXXXXXXXXX	XX-XX-XXXX	<p>Applicant: The home received 2 feet of water which caused damage to the walls and floor. Strong winds damaged the roof covering which allowed rain water to enter home and cause damage to some of the ceilings, walls, and floors.</p> <p>DCT Inspector: Exterior: roof, siding and piers; Interior: ceiling, walls and floors.</p> <p>ECR Inspector: Roof is damaged. Some ceilings and walls are damaged.</p>

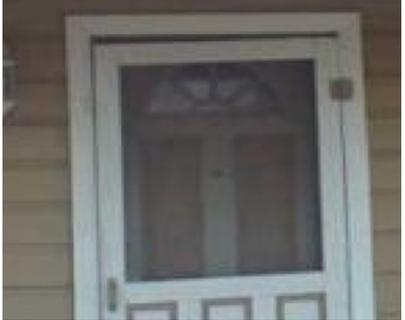
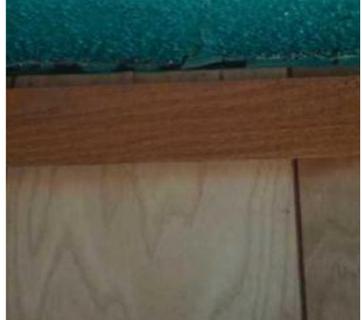
Activity Number	Inspection Date	Evidence of Storm Damage	Photographic Evidence of Storm Damage	
XXXXXXXXXX	XX-XX-XXXX	<p>Applicant: Strong winds damaged the roof covering which allowed rain water to enter home and cause damage; unable to get photo of exterior damage due to lattice being in the way.</p> <p>ECR Inspector: The roof was never replaced after the storm and there is evidence of repaired leaks and possible new leaks in some ceilings. Even though some ceilings and floors were replaced the workmanship was poor.</p>

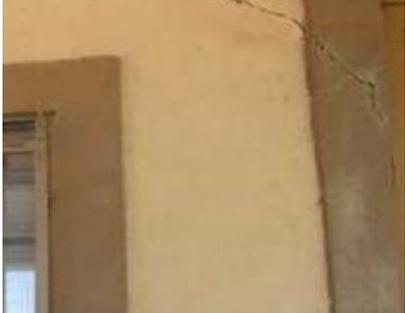
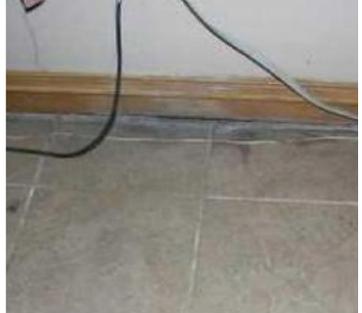
XXXXXXXXXX	XX-XX-XXXX	<p>Applicant: The area beneath the home received several feet of flood water which caused damage to the foundation and subfloor. Strong winds also damaged the roof covering which allowed rain water to enter the home and cause damage to some of the ceilings and walls.</p> <p>DCT Inspector: Applicant advised that he noticed house was shifting two years ago. Interior: cracks on ceiling and walls. Floor is buckling.</p> <p>ECR Inspector: Some cracking in the stucco. Some ceilings and walls have water damage. The flooring is damaged.</p>

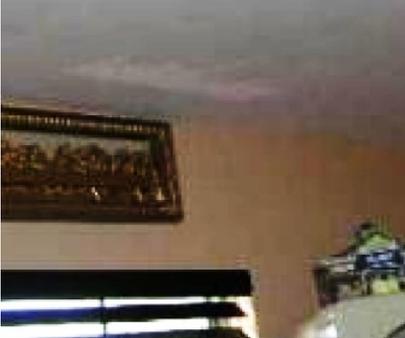
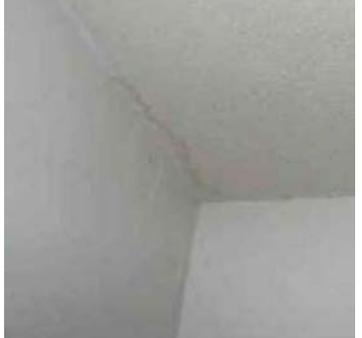
XXXXXXXXXX	XX-XX-XXXX	<p>Applicant: Strong winds damaged the roof covering which allowed rain water to enter the home and cause damage to some of the ceilings and walls.</p> <p>DCT Inspector: Interior: small area of ceiling and wall in laundry room is damaged; Exterior: none.</p> <p>ECR Inspector: Ceiling is damaged in Laundry Room</p>

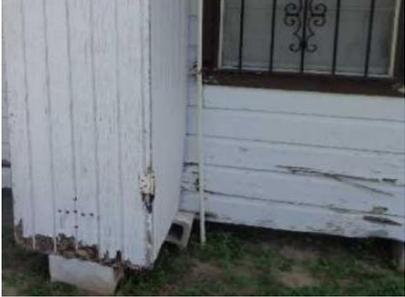
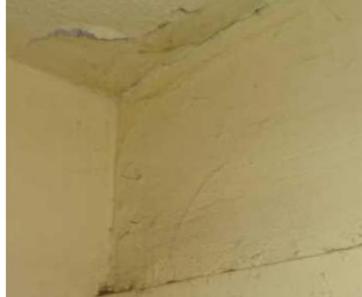
XXXXXXXXXX	XX-XX-XXXX	<p>Applicant: The area beneath the home received 1-2 feet of water from the storm surge which caused damage to some of the electrical components. Strong winds also damaged the roof covering which allowed rain water to enter the home and cause damage to some of the ceilings and walls.</p> <p>DCT Inspector: Exterior: piers and roofing; Interior: ceiling, walls and floors.</p> <p>ECR Inspector: Roof is damaged. Wood siding is damaged or missing. Some of the fascia is damaged. The ceiling and walls are damaged in some of the rooms. The subflooring needs to be replaced.</p>
